ValueCheck Home Inspections Inc.

Inspection Report

123 Main St, Anytown, MI 48111
Inspection prepared for: Home Buyer Harry
Date of Inspection: 3/24/2021 Time: 10:00 AM
Age of Home: 1994 Size: 2857
Order ID: 12622

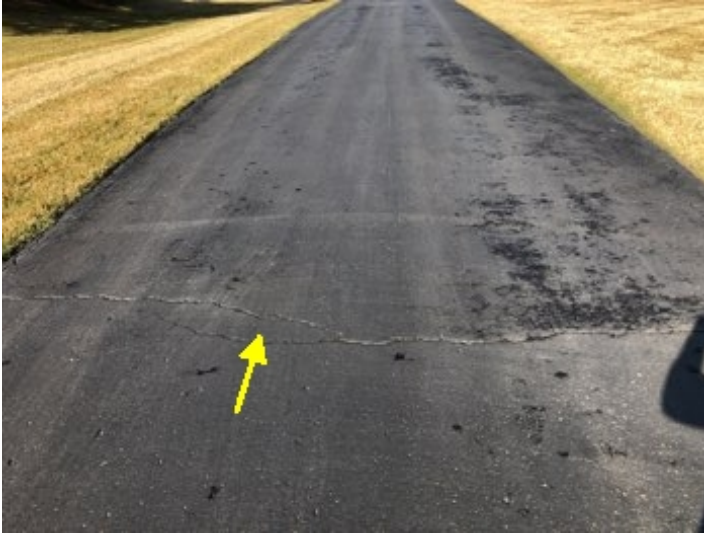
- There are cracks present.

Minor Cracking

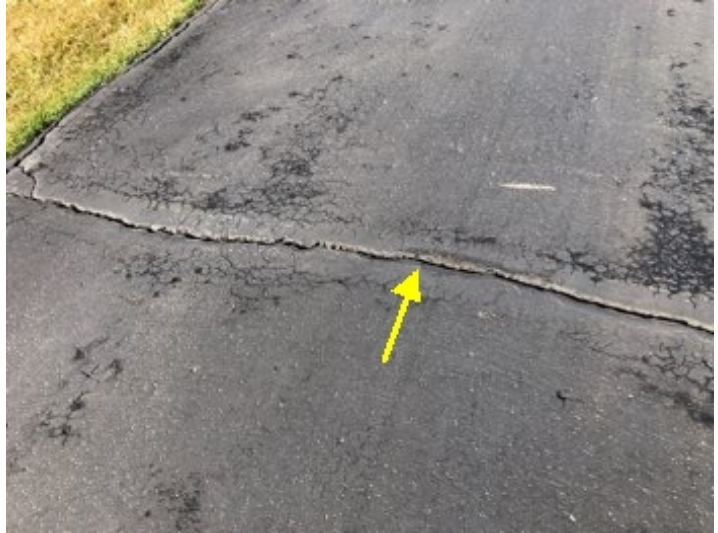
Minor Cracking

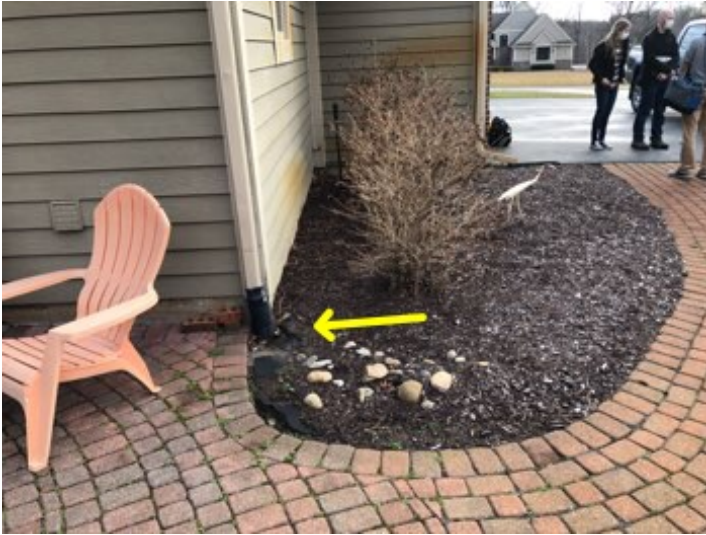
- Parts of the grade slopes towards the foundation, this may contribute to water problems in below grade area's of the house or with the foundation.

The grade slopes towards the foundation

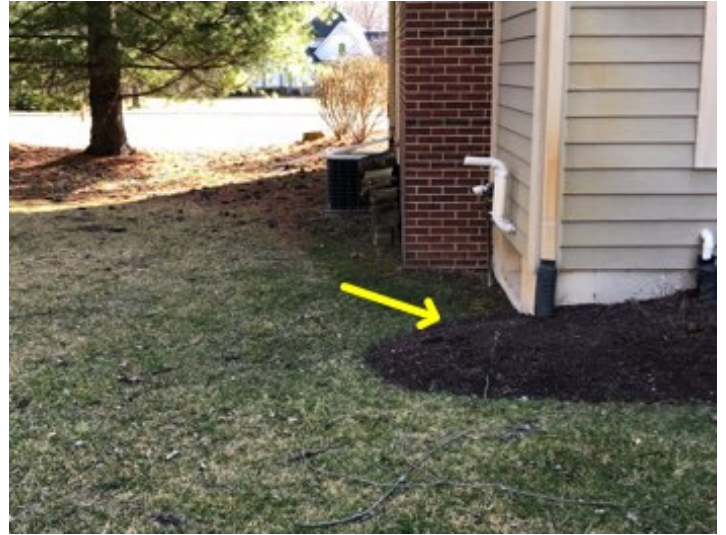
The grade slopes towards the foundation

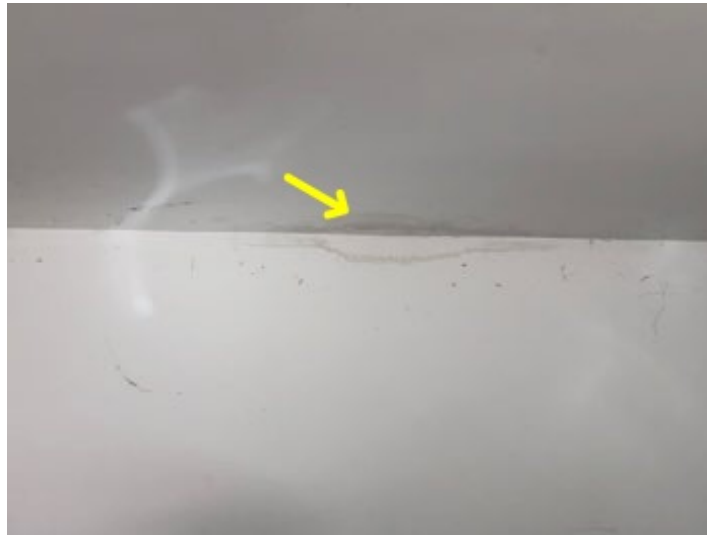
- There were visible water stains.
- I recommend you ask the seller about past or current problems.
- The water stain was dry at the time of inspection when tested with an electronic moisture meter.

Water stain

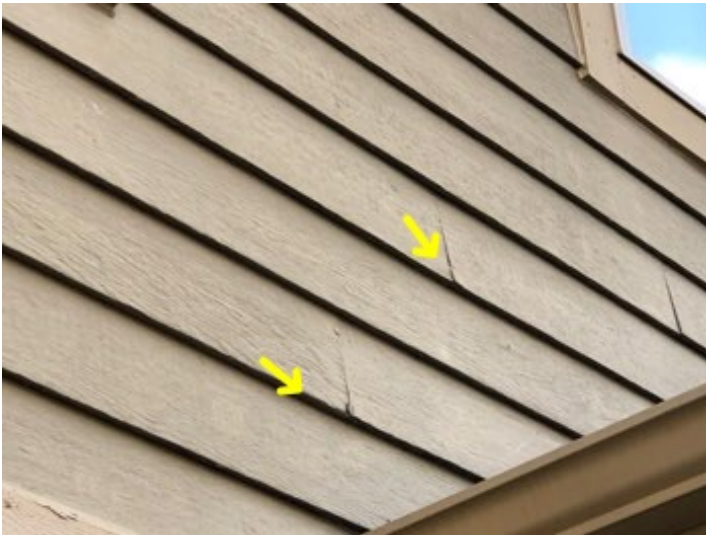
- Wood fiberboard or OSB siding is prone to water problems if not properly maintained. The siding needs to be kept well painted and caulked, any problems should be dealt with ASAP to prevent serious damage and costly repairs.
- There are multiple areas where there is water damage ranging from serious to minor. I have included pictures of some of the damage. I recommend you have this siding further evaluated by a qualified contractor including getting cost estimates for repair.

Water damage and delamination

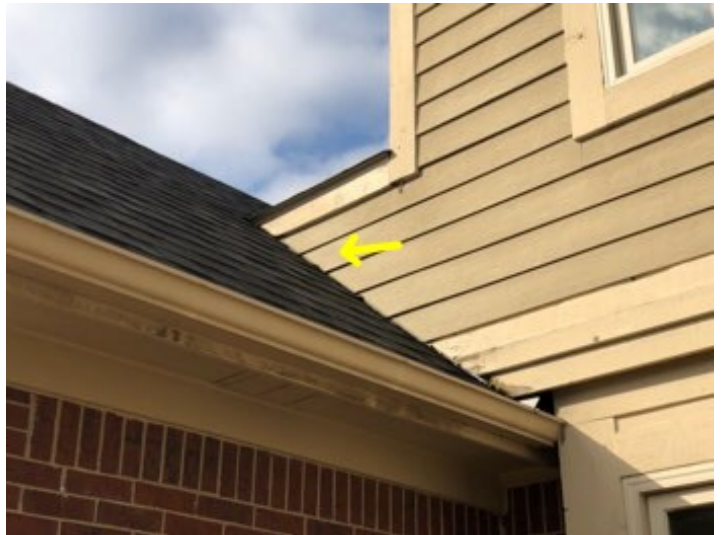
Water damage and deterioration

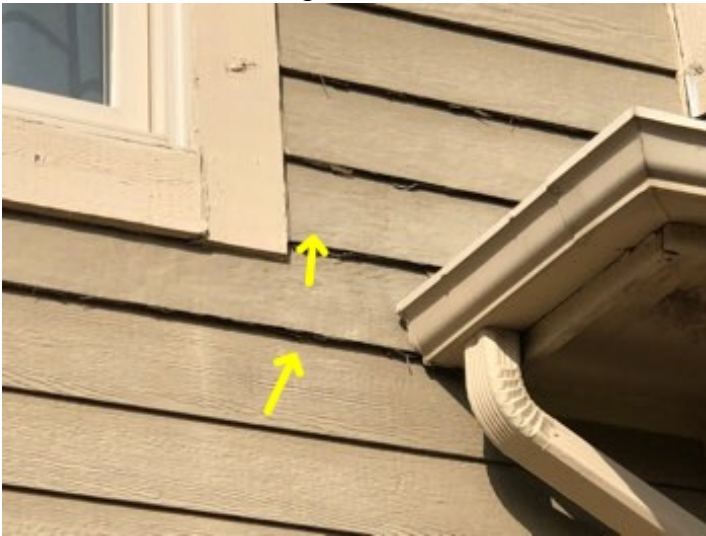
Water damage and deterioration

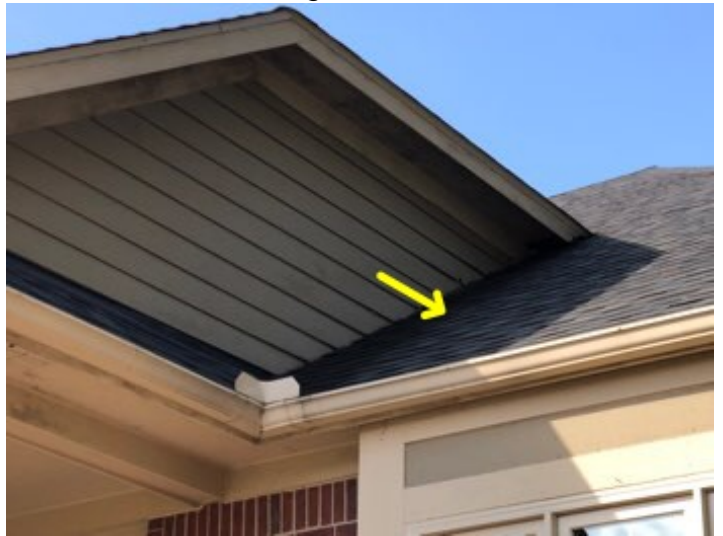
Improper clearance to the roof shingles

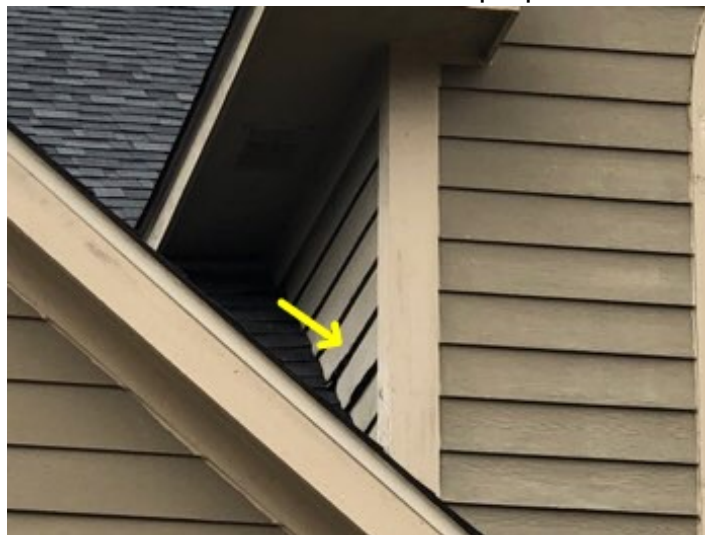
Water damage and Deterioration

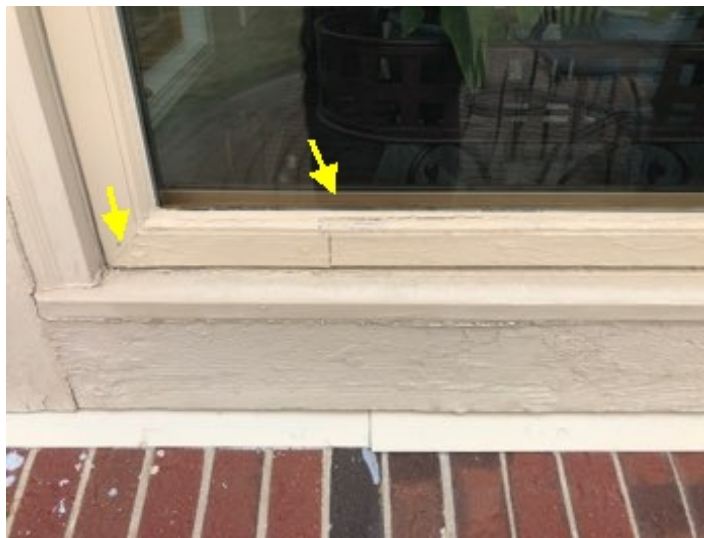
- The windows at the rear addition are showing signs of wear. They should be painted to extend their life. The rest of the house has newer windows. The addition windows may need to be replaced in the future.

Peeling paint and minor decay

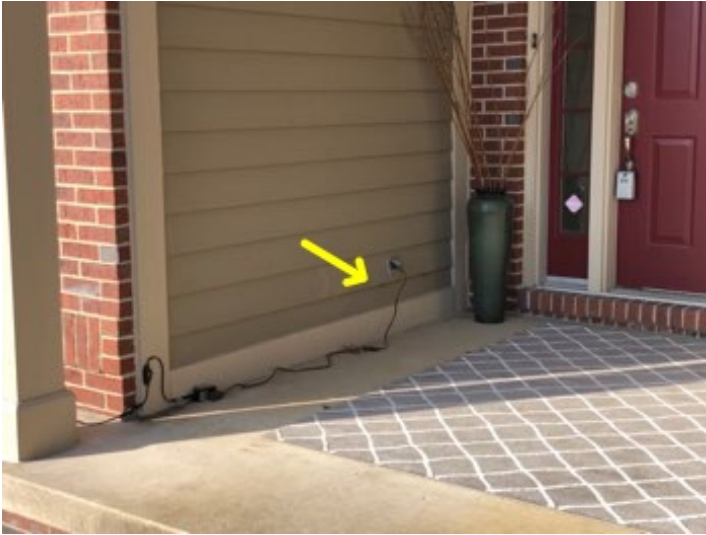
- The **GFCI** outlets in the master bath and front porch did not trip off properly
- I recommend that you have an electrician make the proper repairs as they determine necessary.

This GFCI outlet is not tripping off properly.

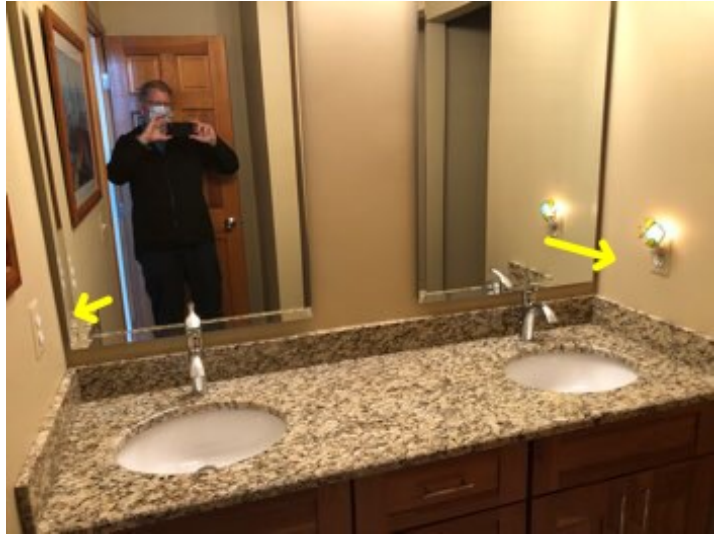
This GFCI outlet is not tripping off properly.

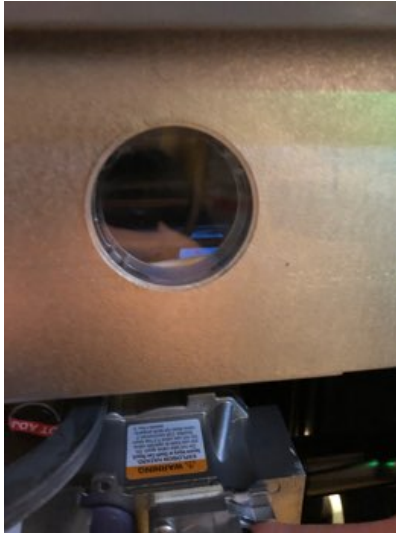
The furnace was working at the time of the inspection.

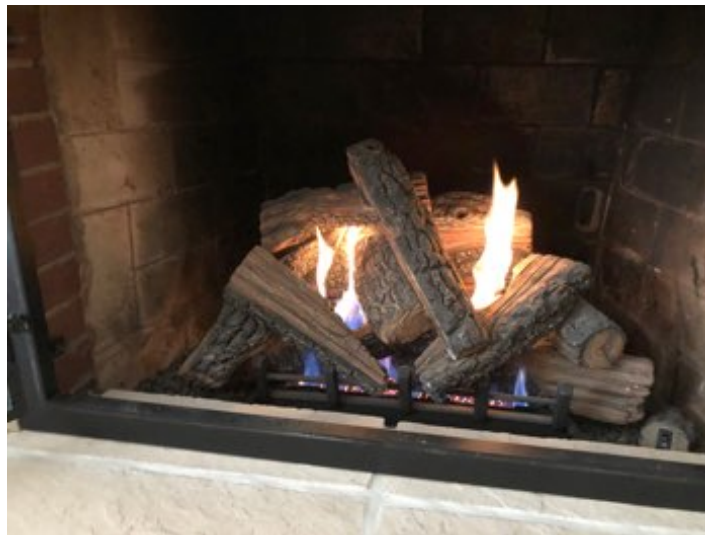
The gas fireplace was working

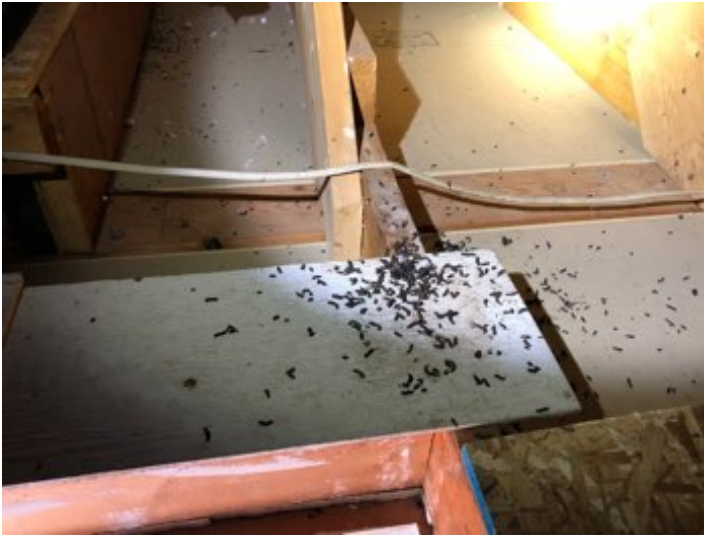
- There are bat droppings in the attic. I do not know the extent of the infestation or the extent of any damage. I recommend that you have this investigated by a qualified pest inspector.
- There are paths through the insulation that indicate some type of rodent activity.

Bat Droppings

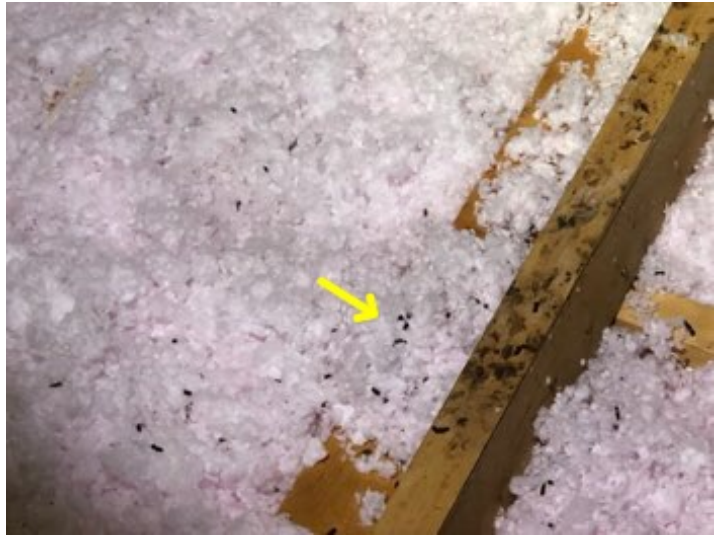
Bat Droppings
