## General Information

Inspector Name Mark Mustola  
Company Name ValueCheck Home Inspections, Inc.  
Company Address 16489 Hi-Land Tr.  
City Linden State MI Zip 48451

Others Present Client, Home Owner Property Occupied Yes  
Estimated Age 1972 Entrance Faces West  
Inspection Date 03/02/2011  
Start Time 8:50am End Time 11:00am  
Electric On Yes  
Gas/Oil On Yes  
Water On Yes  
Temperature 27 degrees  
Weather Sunny Soil Conditions Frozen and snow covered  
Space Below Grade Basement  
Building Type Single family Garage Attached  
Sewage Disposal City How Verified Local Knowledge  
Water Source Well How Verified Local Knowledge  
Additions/Modifications Unknown  
Permits Obtained Unknown How Verified N/A

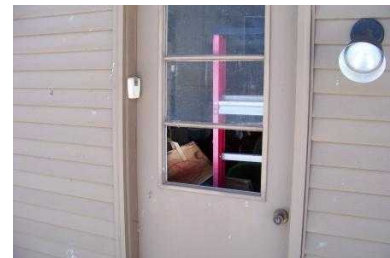
Type of Structure: Attached Car Spaces: 2  
Satisfactory Garage Doors: Wood  
Satisfactory Door Operation: Mechanized  
Satisfactory Door Opener: Genie  
Marginal Service Doors: Wood- Broken or missing glass

**Attached Garage Service Doors: Wood-** Broken or missing glass

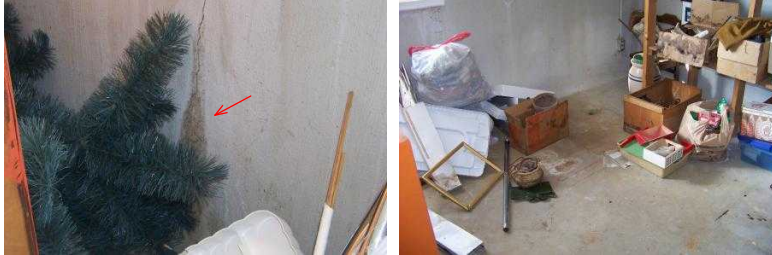
**Moisture Location:** Moderate moisture present- Signs of water seepage at SW corner, I Recommend you have a qualified basement water proofing contractor determine the extent of the water seepage problem and correct the problems as they determine necessary

**Main Basement Moisture Location: Moderate moisture present-** Signs of water seepage at SW corner, I Recommend you have a qualified basement water proofing contractor determine the extent of the water seepage problem and correct the problems as they determine necessary

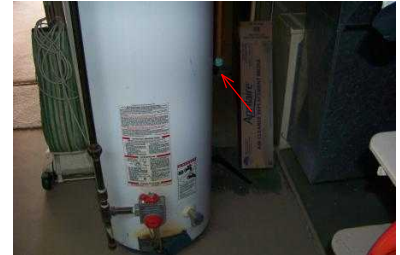
Marginal TPRV and Drain Tube: TPRV with copper extension pipe- TPRV discharge pipe should extend to within is not within 4 inches of the floor
