## General Information

Inspector Name Mark Mustola  
Company Name ValueCheck Home Inspections, Inc.  
Company Address 16489 Hi-Land Tr.  
City Linden State MI Zip 48451

Others Present Client, Home Owner Property Occupied Yes  
Estimated Age 1972 Entrance Faces West  
Inspection Date 03/02/2011  
Start Time 8:50am End Time 11:00am  
Electric On Yes  
Gas/Oil On Yes  
Water On Yes  
Temperature 27 degrees  
Weather Sunny Soil Conditions Frozen and snow covered  
Space Below Grade Basement  
Building Type Single family Garage Attached  
Sewage Disposal City How Verified Local Knowledge  
Water Source Well How Verified Local Knowledge  
Additions/Modifications Unknown  
Permits Obtained Unknown How Verified N/A

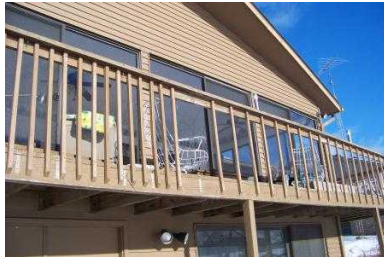
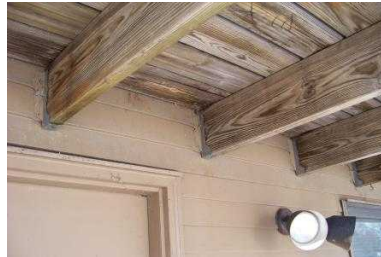
Satisfactory Driveway: Concrete- Cracked, Surface flaking  
Satisfactory Steps/Stoops: Concrete  
Satisfactory Porch: Concrete  
Satisfactory Patio: Concrete  
Marginal Deck: Wood- The following problems were observed, improper attachment to the house, improper baluster attachment and spacing, improper post attachment, deck is sagging, deck is unsafe. I recommend that you have a license contractor repair or replace the deck as they determine necessary

**Deck: Wood-** The following problems were observed, improper attachment to the house, improper baluster attachment and spacing, improper post attachment, deck is sagging, deck is unsafe. I recommend that you have a license contractor repair or replace the deck as they determine necessary

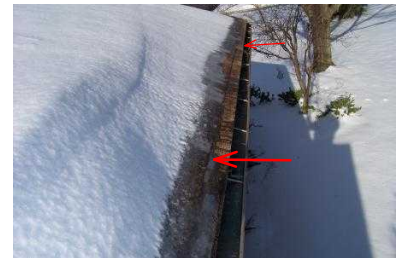
Main Roof Surface  
Method of Inspection: On roof  
Type: Gable  
Approx Age: 7 to 10 years  
Marginal Material: Asphalt shingle- Roof shows signs of ice damming problems

**Main Roof Surface Material: Asphalt shingle-** Roof shows signs of ice damming problems  
**South Chimney Chimney: Brick-** chimney cap / mortar wash is cracked or breaking up, loose bricks, I recommend that you have a qualified contractor repair the chimney as they determine necessary

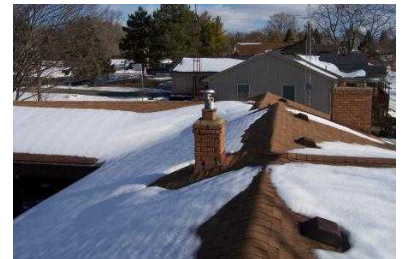
Not Inspected Unable to Inspect: 50%- Due to snow or ice cover, the comments reflect only the visible portion of the roof

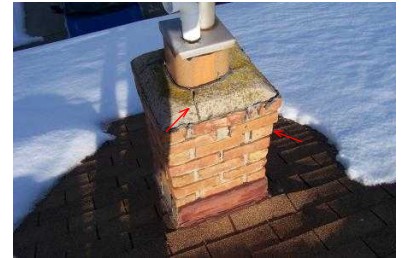
Marginal Chimney: Brick- chimney cap / mortar wash is cracked or breaking up, loose bricks, I recommend that you have a qualified contractor repair the chimney as they determine necessary

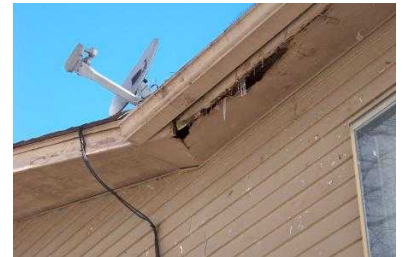
Satisfactory Type: Brick veneer, Aluminum siding  
 Satisfactory Trim: Wood  
 Marginal Fascia: Wood- there is a large hole at the south side of the house

**Fascia: Wood-** there is a large hole at the south side of the house

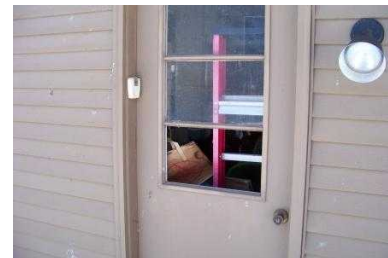
Type of Structure: Attached Car Spaces: 2  
 Satisfactory Garage Doors: Wood  
 Satisfactory Door Operation: Mechanized  
 Satisfactory Door Opener: Genie  
 Marginal Service Doors: Wood- Broken or missing glass

**Attached Garage Service Doors: Wood-** Broken or missing glass

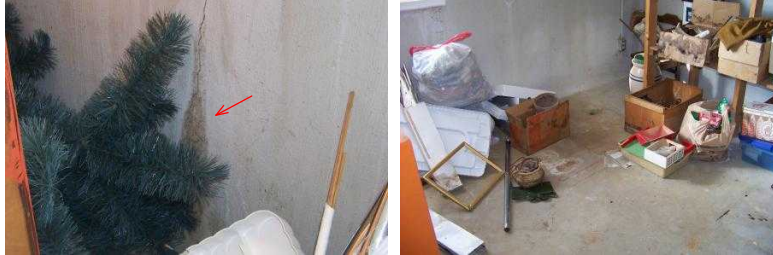
**Moisture Location:** Moderate moisture present- Signs of water seepage at SW corner, I Recommend you have a qualified basement water proofing contractor determine the extent of the water seepage problem and correct the problems as they determine necessary

**Main Basement Moisture Location: Moderate moisture present-** Signs of water seepage at SW corner, I Recommend you have a qualified basement water proofing contractor determine the extent of the water seepage problem and correct the problems as they determine necessary

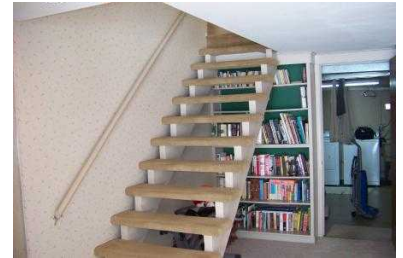
**Bsmt Stairs/Railings:** wood stairs, wood handrails- The following fall hazards exist, missing guard rails

**Main Basement Bsmt Stairs/Railings: wood stairs, wood handrails-** The following fall hazards exist, missing guard rails

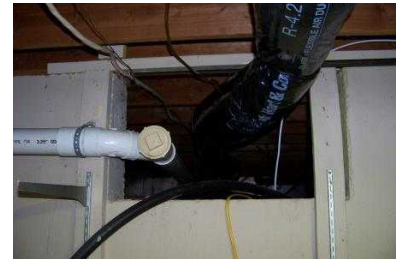
Marginal **Access:** Open- Blocked by HVAC ducts

**kitchen Crawl Space Access: Open-** Blocked by HVAC ducts

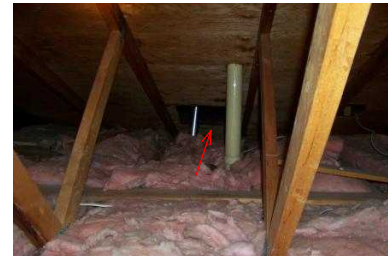
Not Inspected Unable to Inspect: 25%- can not get to space above the back addition, without flooring in place that would allow someone to crawl to the opening between the two spaces

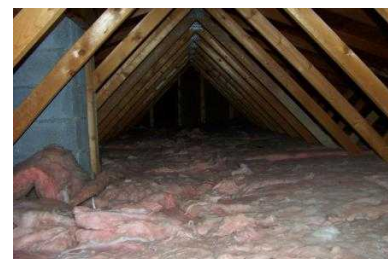
Marginal Insulation Depth: 4 to 6 inches- Insufficient insulation present which can cause ice damming that will lead to roof leaks, 12 inches is recommended by today's standard

**Main Attic Insulation Depth: 4 to 6 inches-** Insufficient insulation present which can cause ice damming that will lead to roof leaks, 12 inches is recommended by today's standard

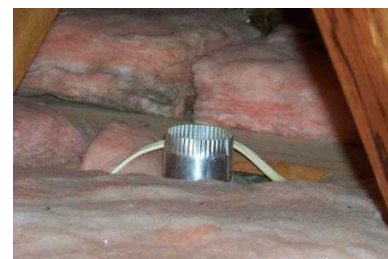
Marginal Bathroom Fan Venting: Electric fan- Bathroom improperly vents into attic, Recommend bathroom vents be vented to outside

**Main Attic Bathroom Fan Venting: Electric fan-** Bathroom improperly vents into attic, Recommend bathroom vents be vented to outside

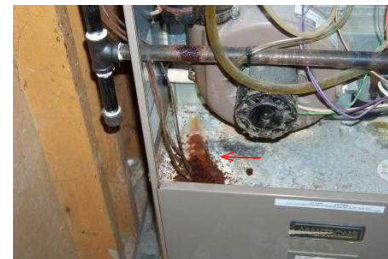
Heating System Operation: Functional- There is condensation leaking from internal furnace parts that can be seen when the cover is removed, I recommend that you have licensed heating contractor clean and service this equipment

**Basement Heating System Heating System Operation: Functional-** There is condensation leaking from internal furnace parts that can be seen when the cover is removed, I recommend that you have licensed heating contractor clean and service this equipment

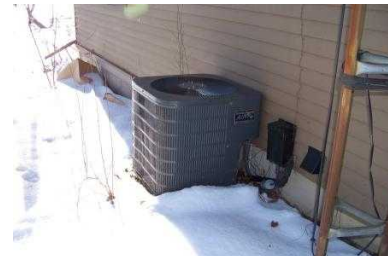
A/C System Operation: AC was not operated- Unit is to close to the house, lack of air flow will reduce the efficiency, To avoid possible compressor damage due to outside temperature below 60 degrees, the unit was not tested.

**Main AC System A/C System Operation: AC was not operated-** Unit is to close to the house, lack of air flow will reduce the efficiency, To avoid possible compressor damage due to outside temperature below 60 degrees, the unit was not tested.

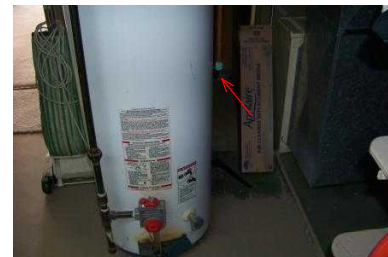
Marginal TPRV and Drain Tube: TPRV with copper extension pipe- TPRV discharge pipe should extend to within is not within 4 inches of the floor

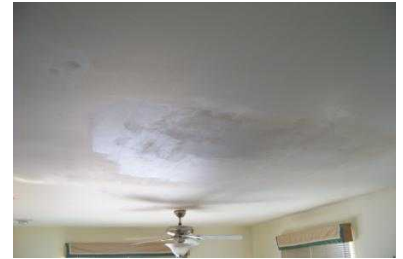
Satisfactory Closet: one walk in  
Marginal Ceiling: Drywall- visible past repairs, I recommend you ask the seller about past or current problems

**Master Bedroom Ceiling:** Drywall- visible past repairs, I recommend you ask the seller about past or current problems

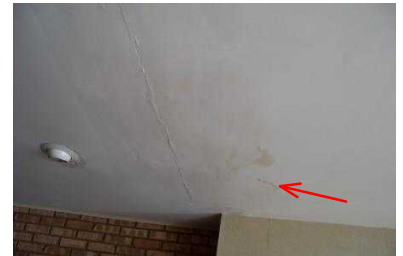
Marginal Ceiling: Drywall- water damage, water stains, I recommend you ask the seller about past or current problems

**Basement Family room Living Space Ceiling:** Drywall- water damage, water stains, I recommend you ask the seller about past or current problems

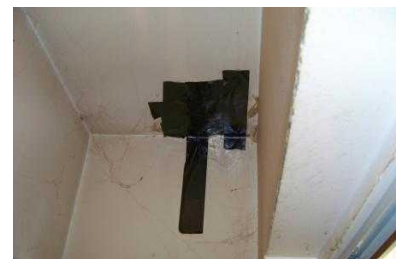
Marginal Ceiling: Drywall- there is duct tape on the deiling in the closet

**1st Floor Kitchen Ceiling:** Drywall- there is duct tape on the deiling in the closet

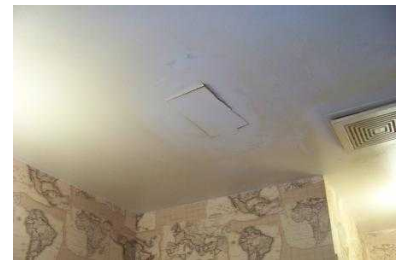
Marginal Ceiling: Drywall- water damage, visible past repairs, I recommend you ask the seller about past or current problems

**Master Bathroom Ceiling:** Drywall- water damage, visible past repairs, I recommend you ask the seller about past or current problems

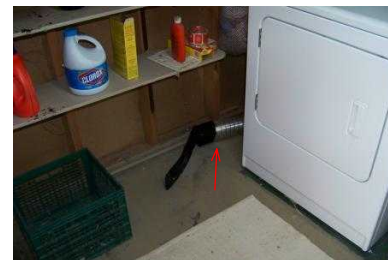
Marginal      Laundry Tub: Plastic- Faucet is leaking  
Satisfactory      Laundry Tub Drain: Electric pump  
Satisfactory      Washer Hose Bib: Gate  
Satisfactory      Washer and Dryer Electrical: 120-240 VAC  
Marginal      Dryer Vent: Metal flex- Recommend venting to outside

**Basement Laundry Room/Area Dryer Vent:** Metal flex- Recommend venting to outside
